NASA TN D-7001

ANNULAR SLIT COLLOID THRUSTER RESEARCH AND DEVELOPMENT

by Kenneth W. Stark and William A. Burton

*Goddard Space Flight Center
Greenbelt, Md. 20771*

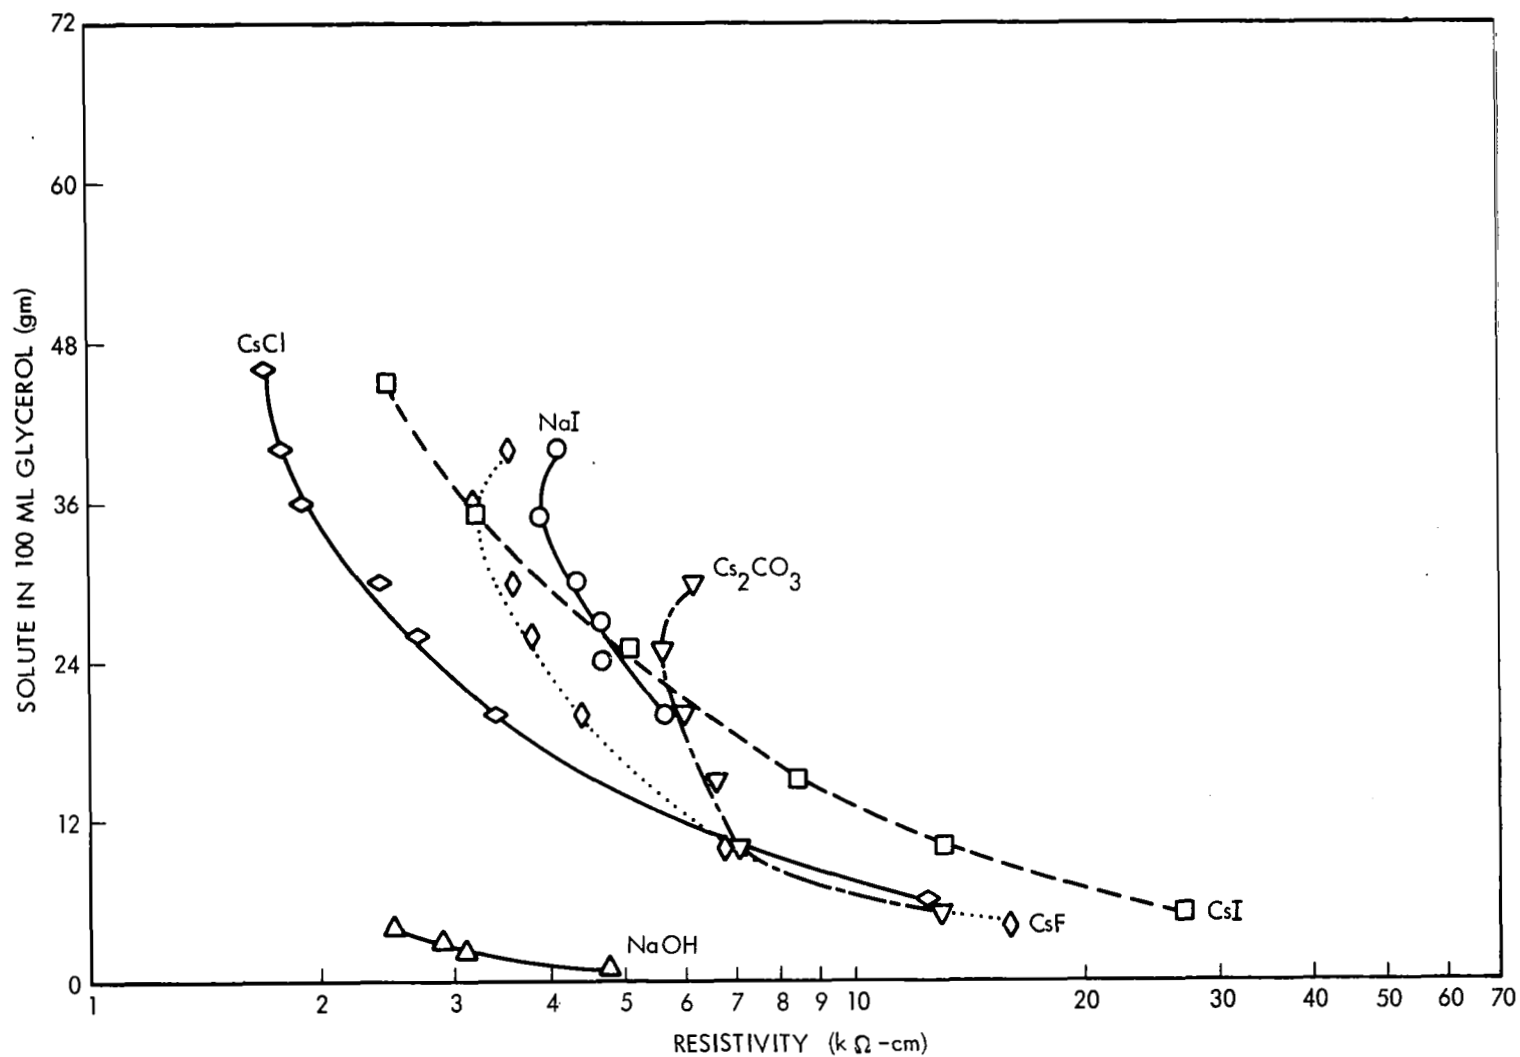
Figure 35—Solution resistivity of various solutes dissolved in 100 ml of glycerol.

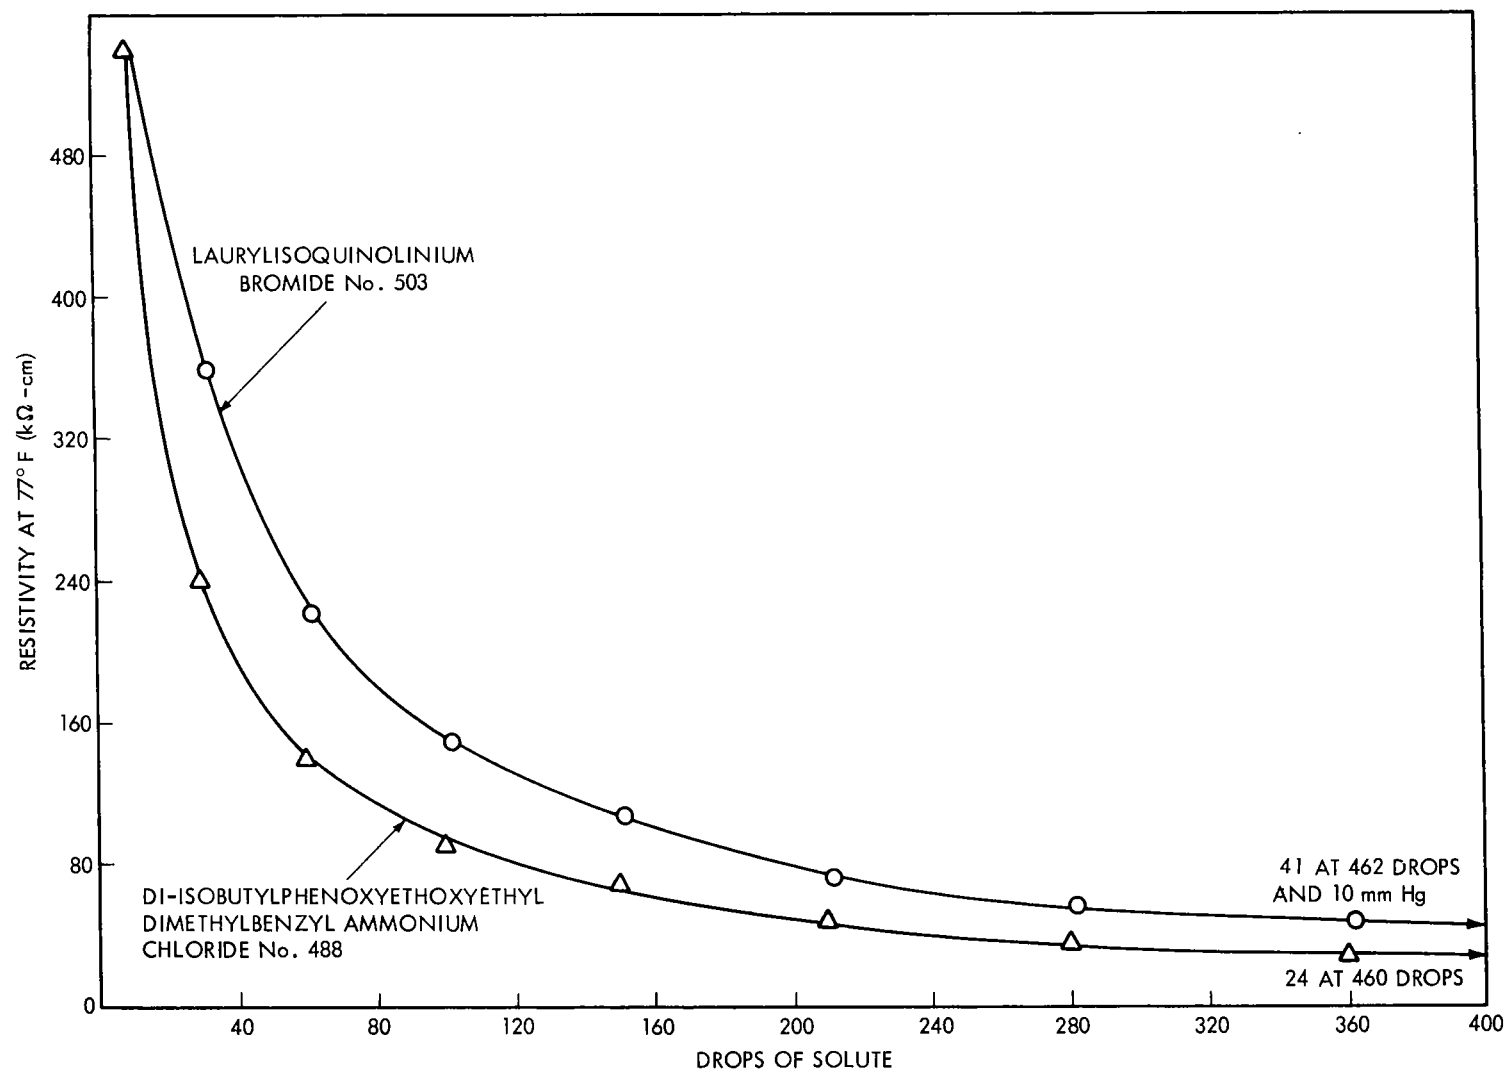
Figure 36 – Solution resistivity of liquid solutes in Carbowax-400.

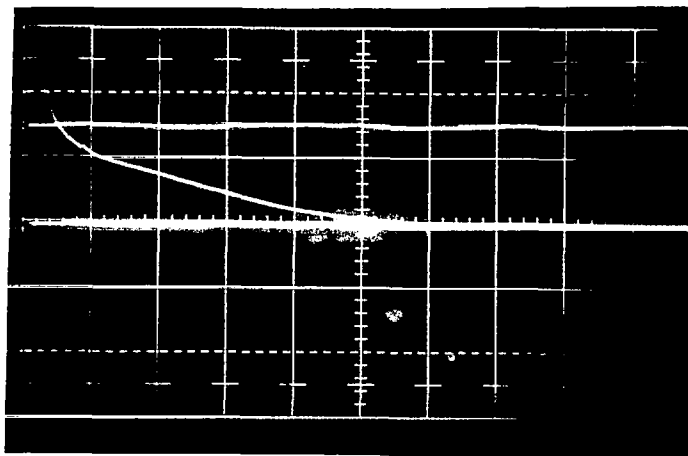
Figure 37—TOF trace of AS-45-1. $V_s = 19$ kV, $I_s = 75$ μ A, $i = 5$ μ A/cm, and the sweep was 50 μ sec/cm.

AS-45 was the first test conducted with a new propellant, propellant No. 1, and with a flow control orifice. At a V_s of 19 kV there was no glow spray; however, performance was far from acceptable. The flow rate was higher than with the glycerol solutions, which obviously contributed to the low performance. The TOF trace is shown in Figure 37.
